COMPOSITE DECKING JOISTS LOAD TESTING

DOCUMENT REFERENCE: DR-5200

PROJECT FILE REFERENCE: S10276

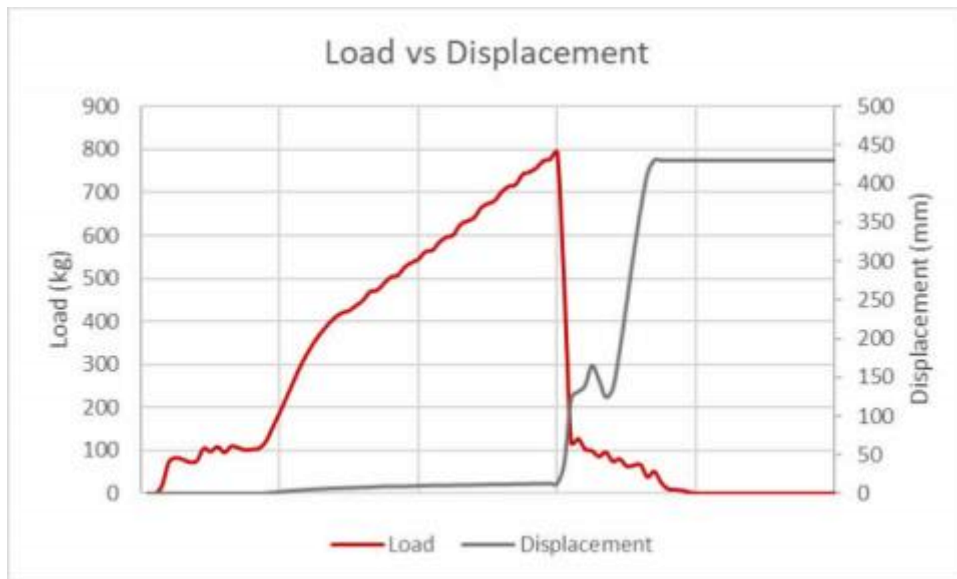
TEST DETAILS: Test 2 – Solid Joist (Span of 1000mm)

Load Achieved (kgs)	Maximum Displacement (mm)
793	13.11

The Solid Joist when assembled and tested in the manor indicated within this certificate achieved a load of 793kg with a maximum recorded displacement of 13.11mm before the sample failed.

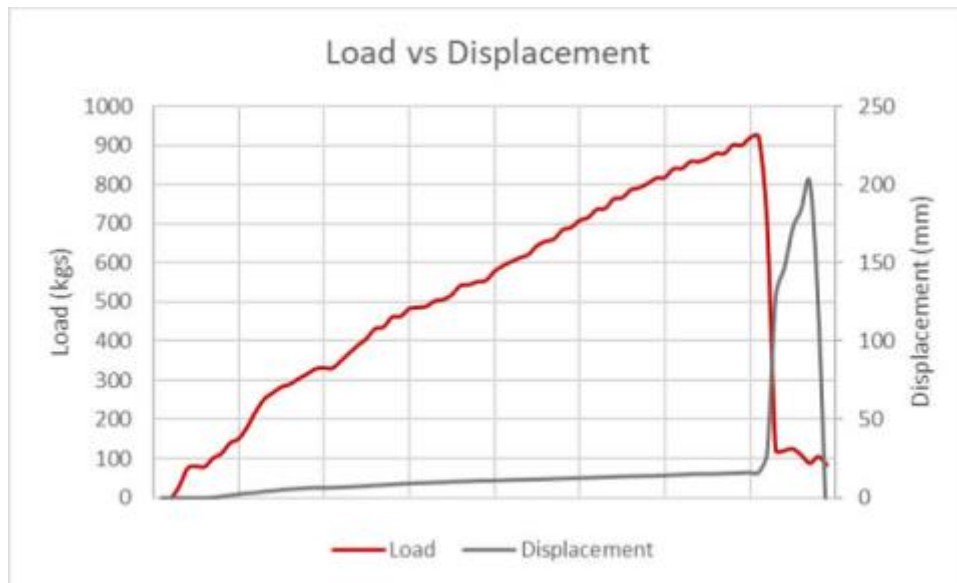
TEST DETAILS: Test 3 – Solid Joist (Span of 1000mm)

Load Achieved (kgs)	Maximum Displacement (mm)
923	16.45

The Solid Joist when assembled and tested in the manor indicated within this certificate achieved a load of 923kg with a maximum recorded displacement of 16.45mm before the sample failed.
